# Manhole Inspection Summary

Manhole # S11II\_015MH

Insp Date: **1/13/09 3:19 PM**

**Location** Address: **3100 NORTH AVE**

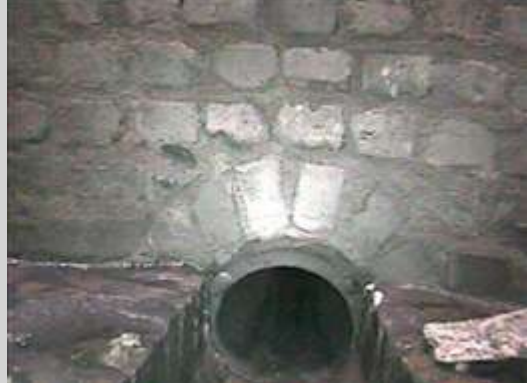
12 O'Clock Outflow

8 in. Circular Gravity Sewer  
Pipe Out @ 12 O'Clock

Pipe Height: (in.) Direct  
Pipe Material: **Clay** ☐ Pipe Lined  
Invert Depth: **10.20** (ft.) Flow Characteristics: **None**  
Deposits: ☒ None ☐ Mud ☐ Gravy ☐ Debris ☐ Grease  
Silt Depth: (in.) Deposits Extent:  
Infiltration: **None** Pipe Seal Cond: **Sound**
